RESERVOIRS

The chapter on Masonry Dams has been increased twofold by an attempt to make some mention of all the most notable dams of the world, and many that are very little known. Attention is particularly directed to Plates 1, 2, and 3, in which profiles are shown of all of the leading and better known masonry dams in existence, drawn to uniform scale for easy graphical comparison. No such complete collection of dam profiles has ever before appeared in print, assembled together on a common basis.

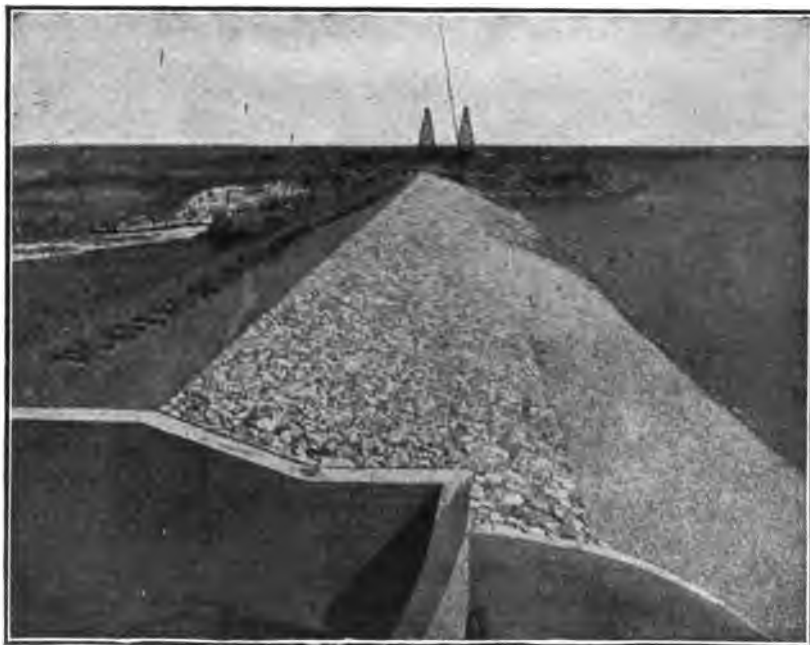
FIG. 61.—MINIDOKA DAM, IDAHO, LOOKING NORTH.

The dam is a rock-fill structure, with earth facing and concrete core-wall. The length of the dam is 625 feet, its maximum height 80 feet above bed-rock, and about 60 feet above the original bed of the stream. The width on the crest is 25 feet, its base averages about 300 feet, and its total volume 191,000 cubic yards. The concrete core-wall is built upon a solid rock foundation throughout the entire length of the dam, and at each end reaches to within about 11 feet of the top of the earth and rock part of the dam, while through the central portion its top is 44 feet below the crest of the dam. The downstream portion of the dam was built of large rocks, of 1000 pounds

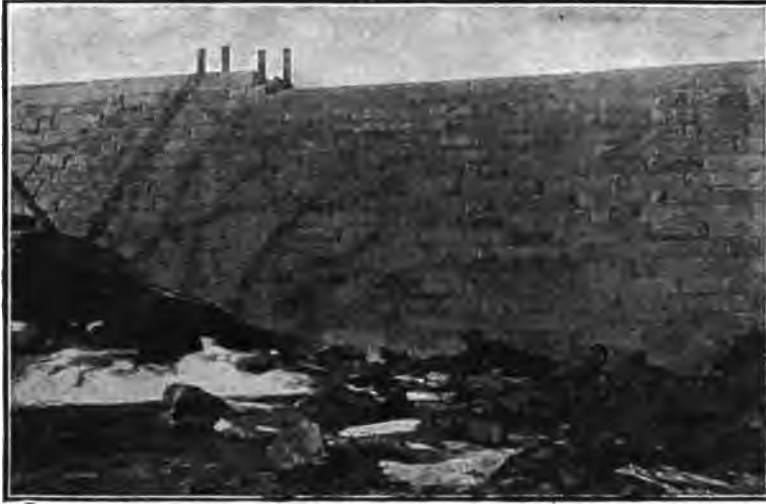
FIG. 63.—ALFRED DAM, ME. DRY ROCK MASONRY WITH CONCRETE FACING AND CREST.

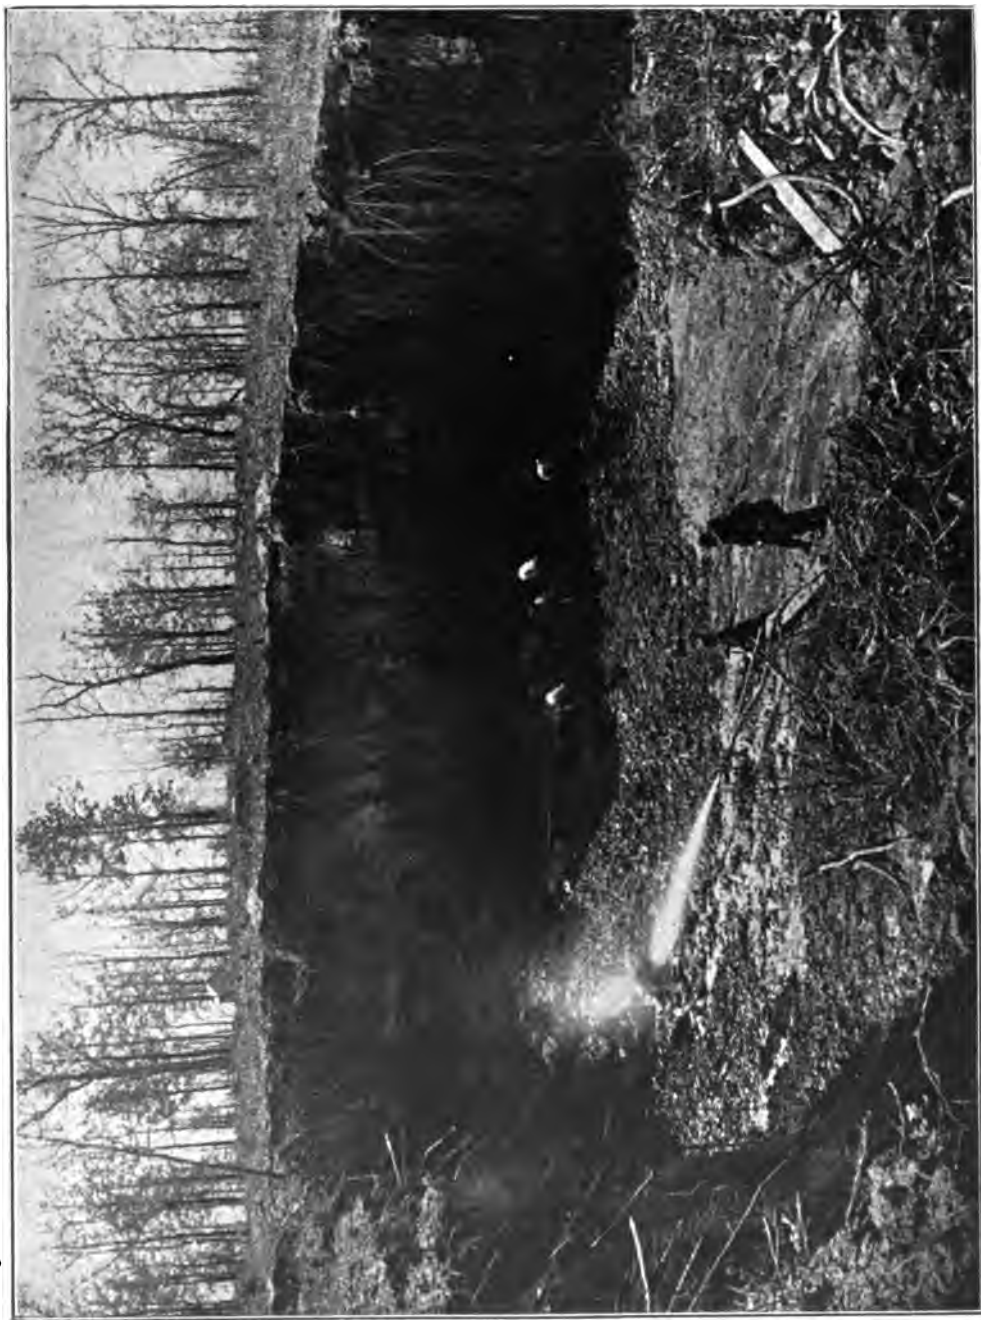
FIG. 68.—HYDRAULIC SLUICING FOR BUILDING DAM AT TYLER, TEXAS.

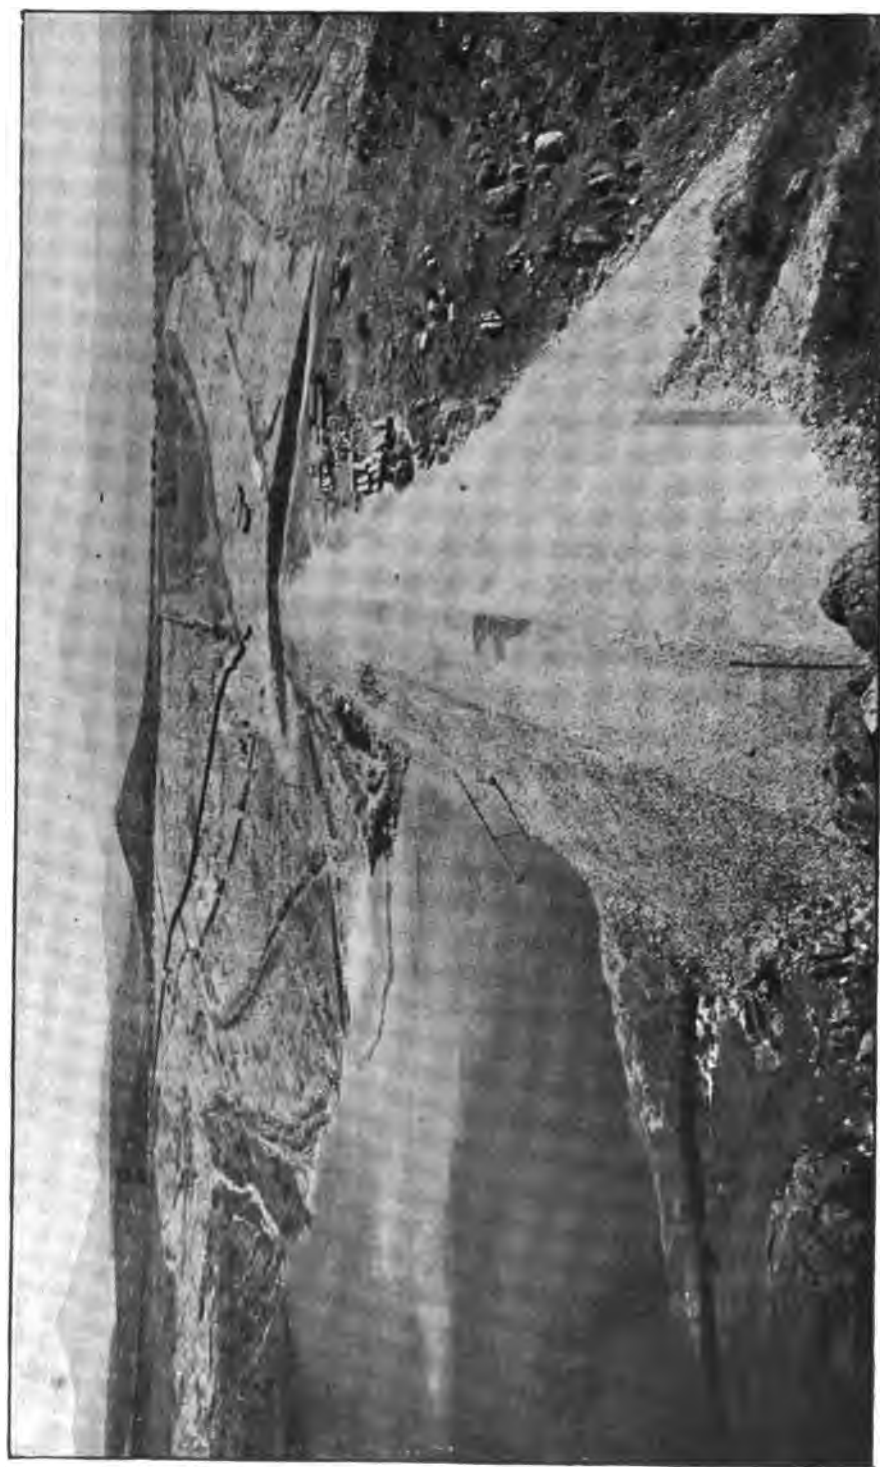
FIG. 70.—VIEW OF FINISHED DAM AND WASTEWAY OF LA MESA RESERVOIR.

In beginning the work a trench was excavated in bed-rock, as shown in Fig. 72, from 2 to 5 feet deep, 20 feet wide at center and tapering to 5 feet at the ends. At right angles to this trench in the bed of the gulch a culvert was built to reach entirely through the dam at its widest point. This culvert, whose details are shown in Fig. 73, consisted of a concrete conduit, 48 inches wide, 30 inches high, extending from the inner face of the dam outward 180 feet, to a point 72 feet from the lower toe, where it connects with two 24-inch cast-iron pipes, that form the outlet to the reservoir. One of these pipes connects with a wood-stave pipe supplying water to San Diego, and the other is used as a waste, or clean-out, pipe. Both are controlled by gate-valves at the toe of the dam. The walls of the concrete culvert are 12 inches in thickness, and four vertical stand-pipes connect with the culvert at intervals of 35 feet from the inside end. These stand-pipes consist of 24-inch vitrified pipes, surrounded with concrete, which pass upward through the body of the dam, and are now used as outlet-pipes to the reservoir at four different levels. During construction they performed the important function of conveying the water into the reservoir after it had dropped its load of gravel and sediment on to the surrounding embankment. They were built up a joint at a time in 2-foot sections, as the work progressed, and were finished off at the top with brass ring and flap-valve, the latter being controlled by rods reaching up the slope through the water to the surface. (See Fig. 70.) These flap-valves can only be opened when pressure is relieved by closing the gate-valves below.

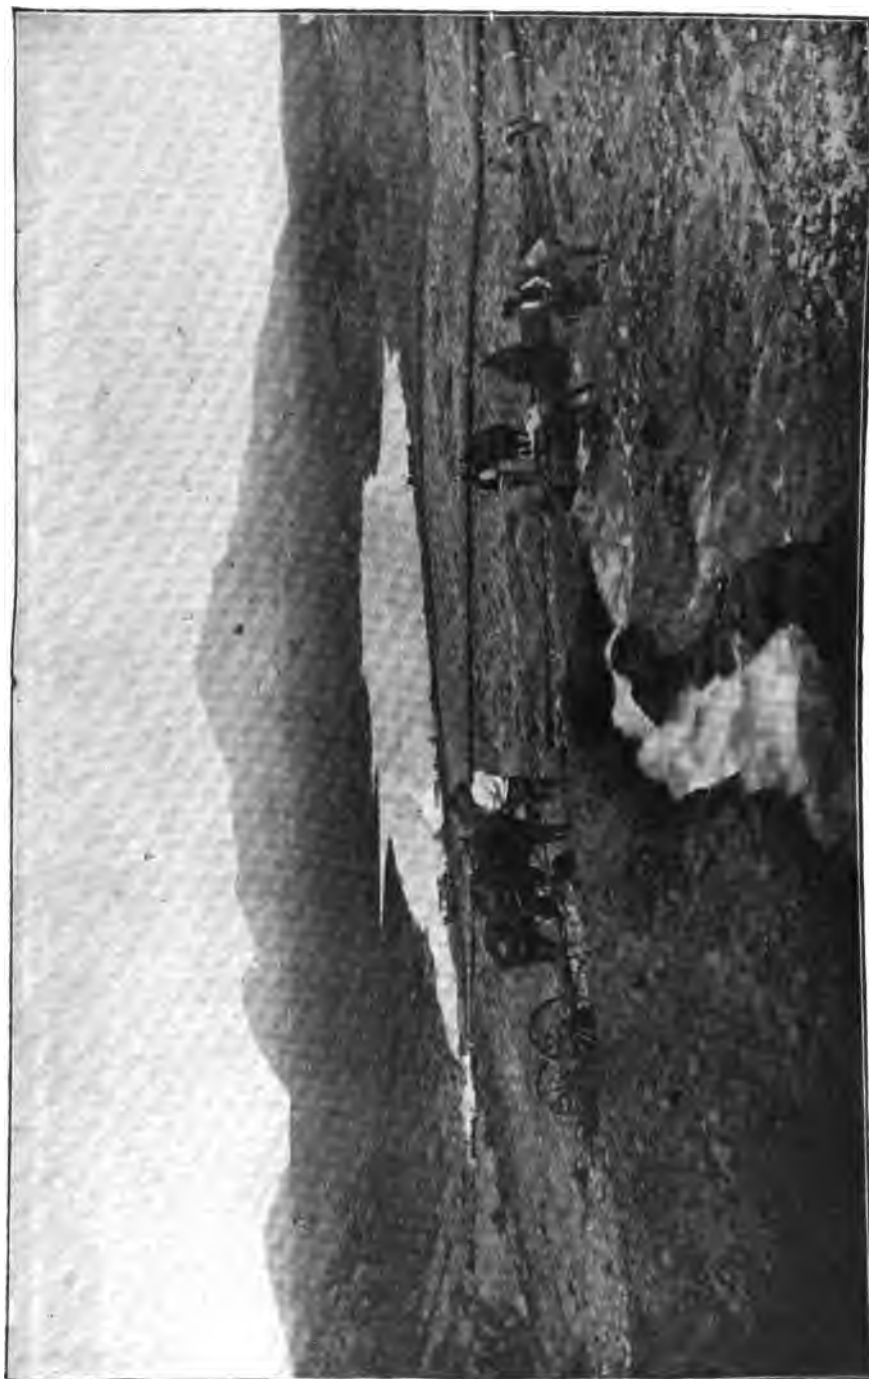
FIG. 71.—LA MESA (CAL.) DAM IN COURSE OF CONSTRUCTION BY THE HYDRAULIC PROCESS.
Showing method of loosening earth to get it in suspension before taking it into carrying conduit. The conduit was built in 20-foot sections, which could be and were frequently taken apart and moved as conditions required.

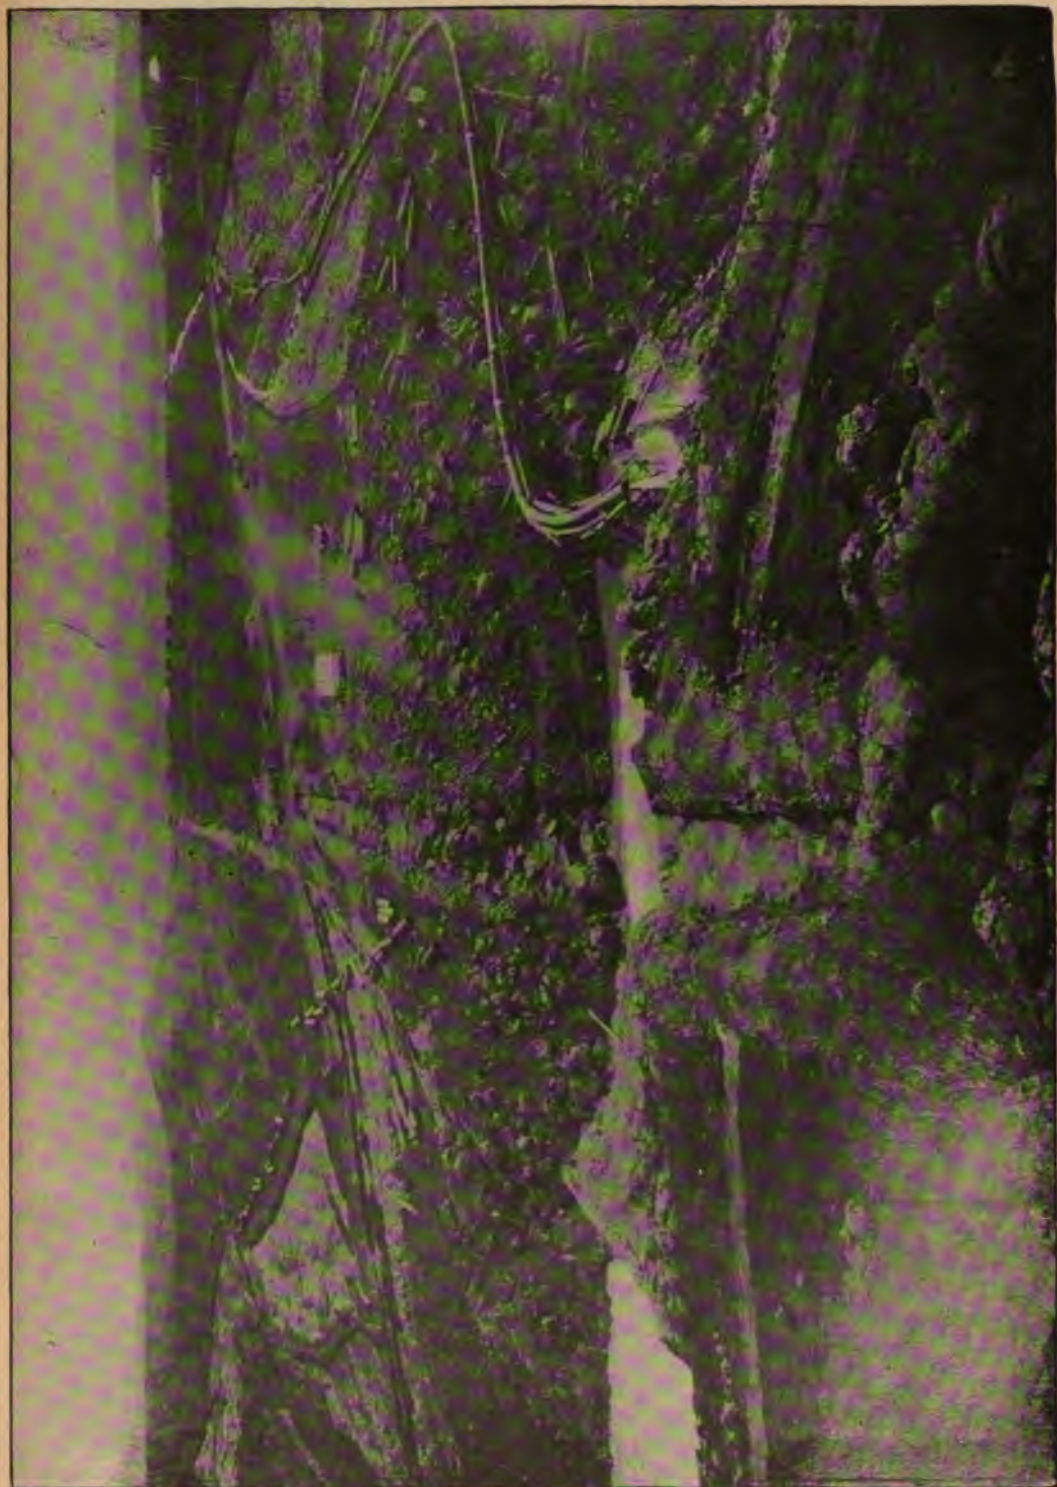
FIG. 72.—LA MESA RESERVOIR. BEGINNING OF THE CONSTRUCTION OF HYDRAULIC-FILL DAM.

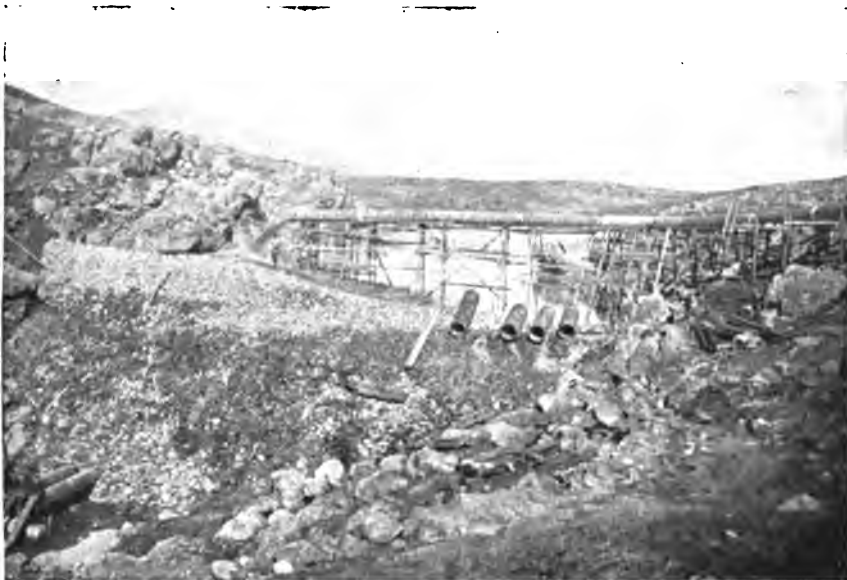
FIG. 76.—LA MESA HYDRAULIC-FILL DAM, SHOWING PIPE DISCHARGING MATERIAL ON THE DAM.

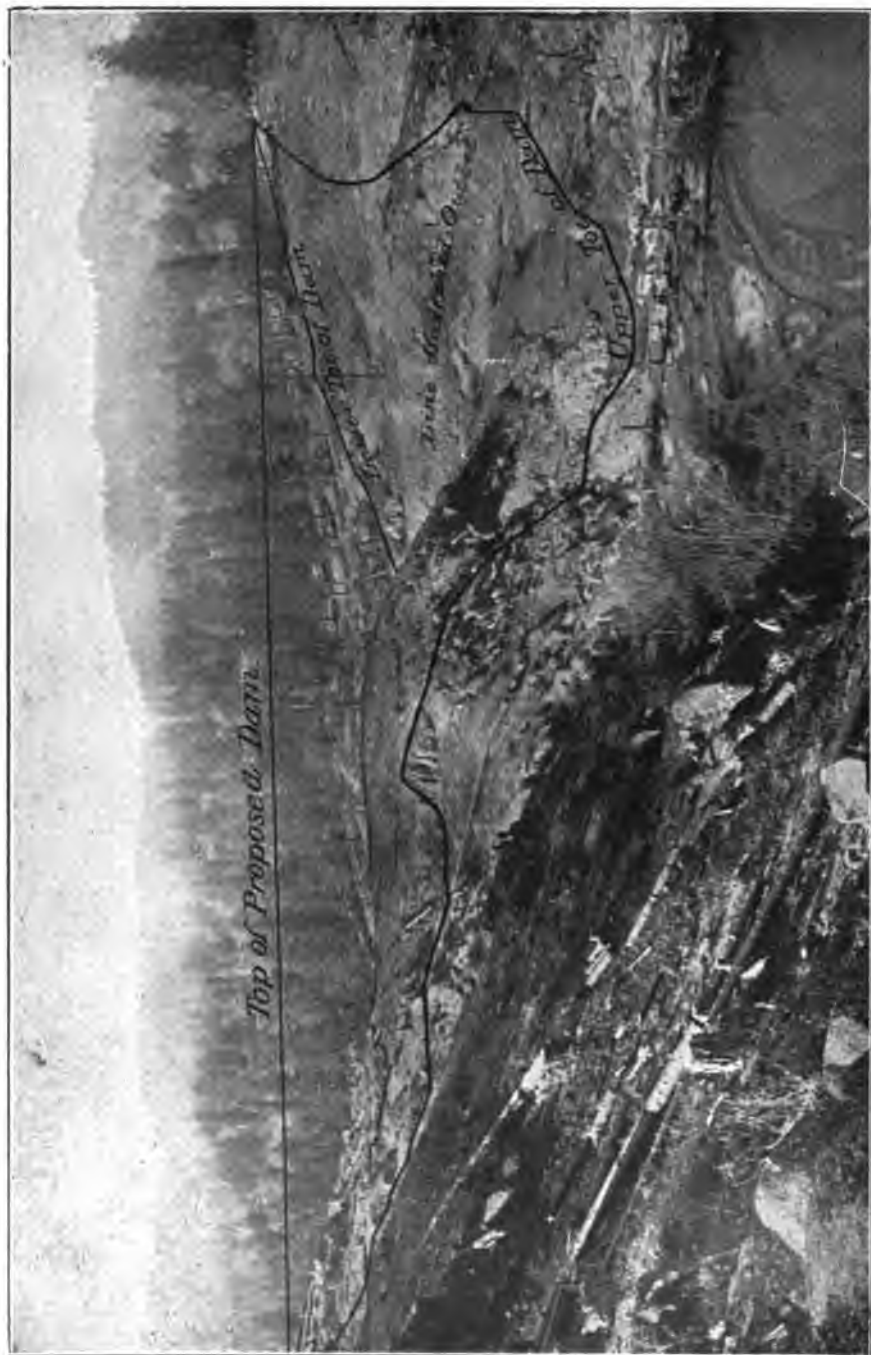
FIG. 77.—VIEW OF CRANE VALLEY DAM-SITE, SHOWING OUTLINES OF HYDRAULIC-FILL DAM.

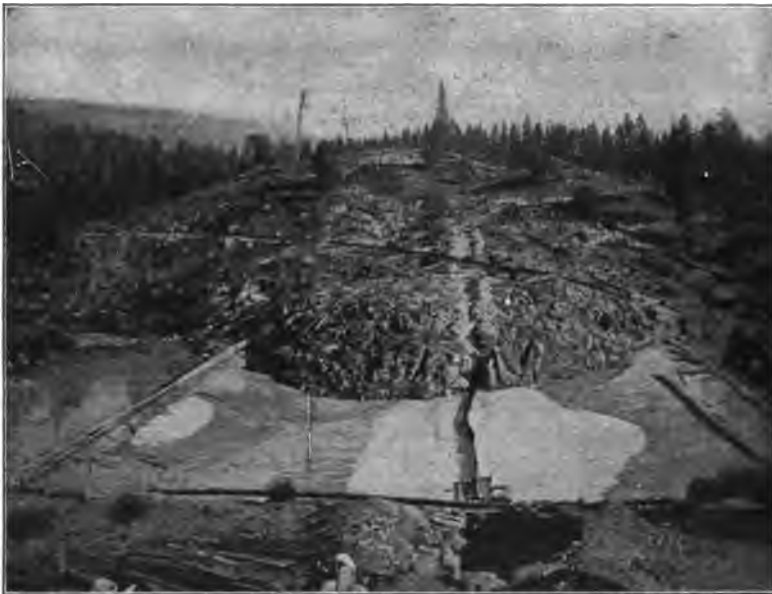
FIG. 79.—CRANE VALLEY DAM. SHOWING WOODEN FENCE, OR CENTER DIAPHRAGM, WHICH WAS CARRIED UP TO A HEIGHT OF 30 FEET ABOVE BED-ROCK.

In preparing the foundations the center line of the dam was excavated to bed-rock and all loose material removed for a width of 20 feet from the center line on the up-stream side. Then a concrete wall, 2 feet in thickness, and about 2 to 5 feet in height, was built on bed-rock, into which was firmly imbedded the footings of a wooden core-wall, of doubled

1-inch surfaced sheeting. This wooden partition was continued to a height of some 30 feet above the base of the dam, its object being mainly to prevent the stratification of material deposited by the water from extending across the center of the dam from either side. It was also designed as a check against percolation through the dam.

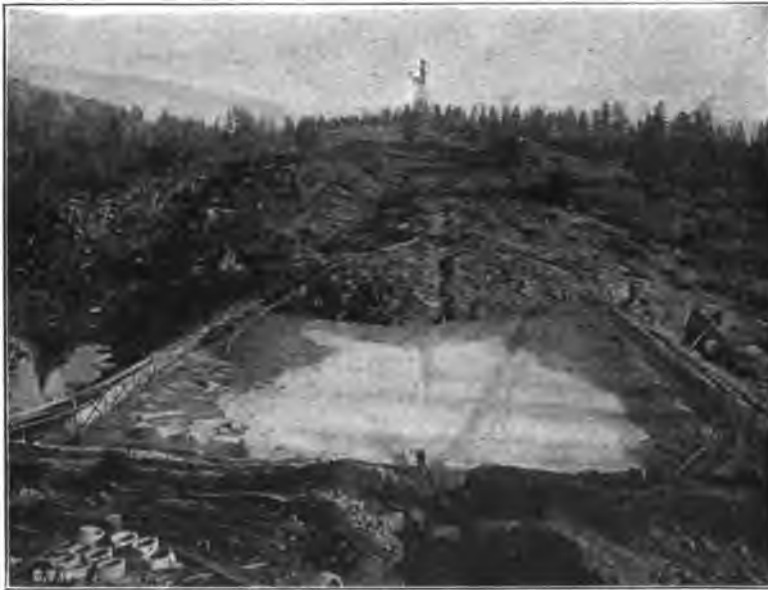
FIG. 80.—CRANE VALLEY DAM SHOWING DISCHARGE OF SLUICED EARTH AT END OF CONVEYING FLUME.

water with its load, was made at convenient points by side gates in the flume, formed of a short section of the side board sawed in such a way that it could be swung across the flume, turning out the entire flow at that point. From these points of discharge the sand and silt were distributed on light grades until the central pool was reached, when precipitation of the sand took place at once, forming bluff banks under the water near its edge, while the fine silt particles were distributed across the pool.

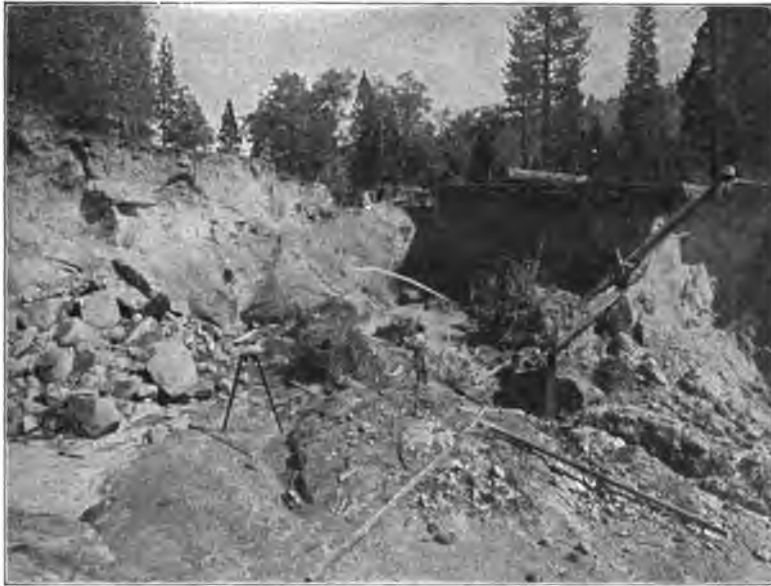
FIG. 81.—CRANE VALLEY HYDRAULIC-FILL DAM. SHOWING METHOD OF LOOSENING THE MATERIALS SLUICED INTO THE DAM.

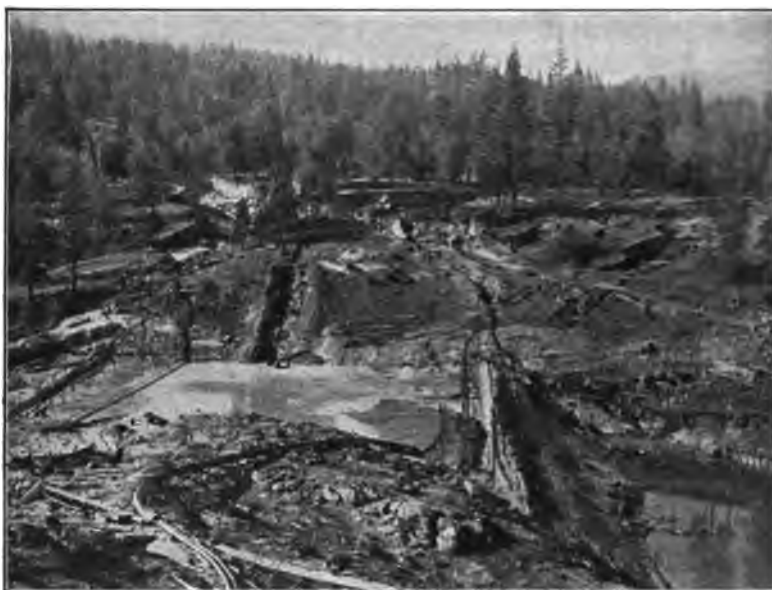
FIG. 82.—BORROW-PITS FROM WHICH MATERIAL WAS SLUICED TO THE CRANE VALLEY DAM IN BACKGROUND.

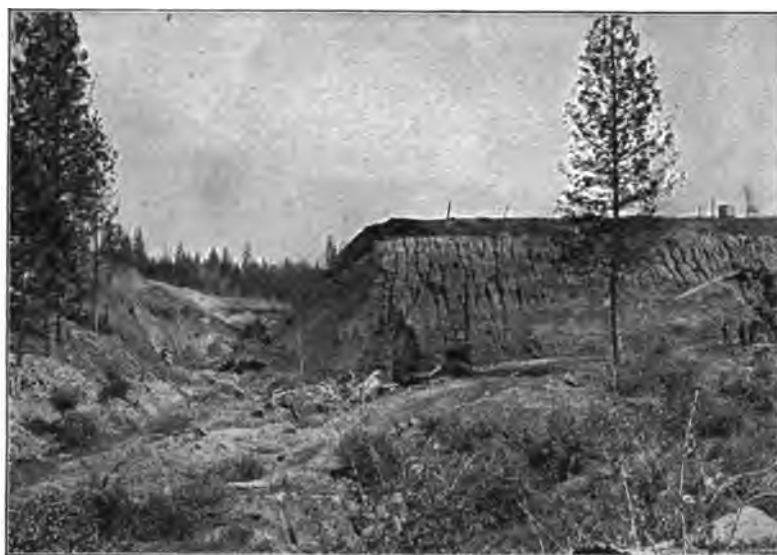
FIG. 84.—BREAK IN ORIGINAL LAKE FRANCES DAM. LOOKING UP STREAM.

and when the water had risen to within six feet of the spillway level, at 11 A.M., Oct. 21, 1899, the dam was suddenly ruptured, and a hole washed through it 100 feet wide at top, extending down to and below the original stream-bed. The dam originally contained 80,265 cubic yards, of which 16,160 cubic yards, or about 20%, were washed away.

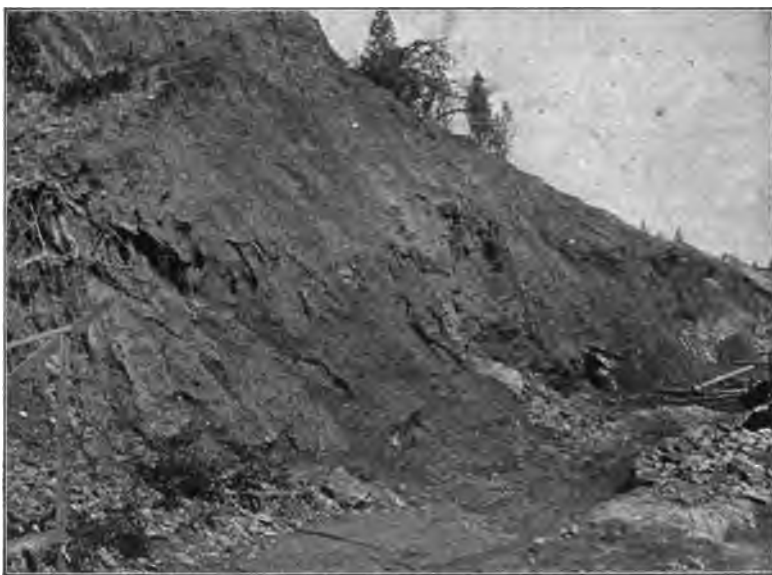
FIG. 85.—NEAR VIEW OF RIGHT SIDE OF BREAK IN EMBANKMENT OF LAKE FRANCES DAM SHOWING ROOTS EXPOSED BY THE BREAK.

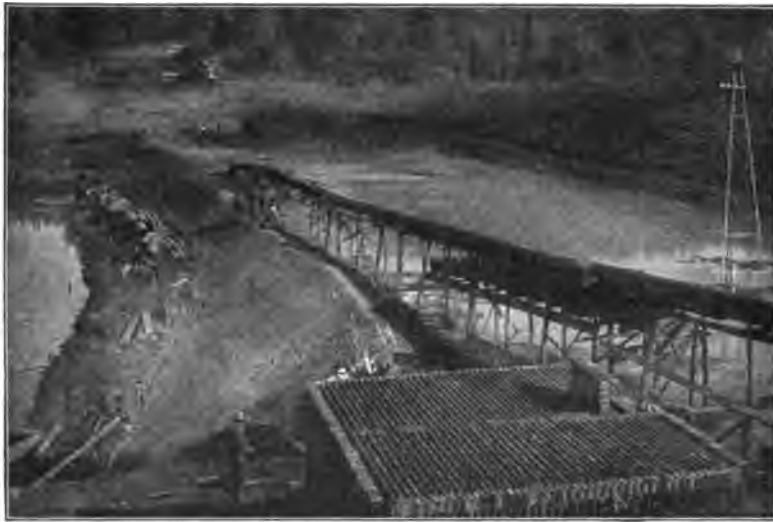
FIG. 86.—TOE LEVEE OF NORTH FACE, LAKE FRANCES DAM, AND INLET CRIB AT HEAD OF FIVE-FOOT OUTLET CULVERT.

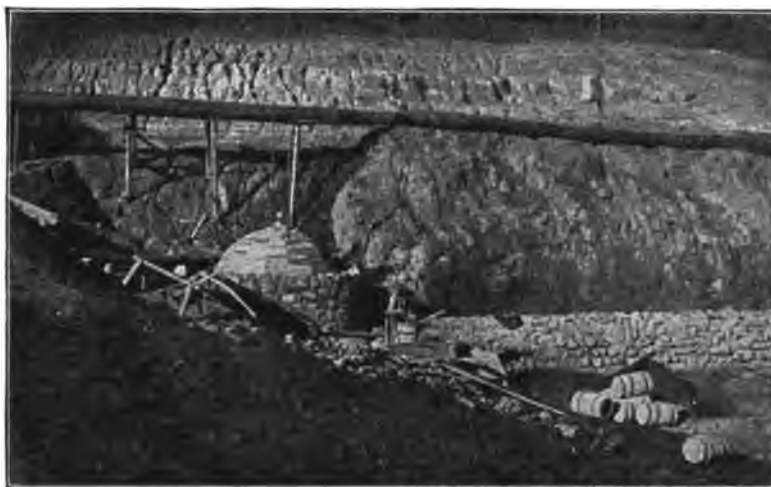
FIG. 87.—DOME ON GATE CHAMBER, LAKE FRANCES DAM; ALSO TWENTY-TWO-INCH SLUICE PIPE.

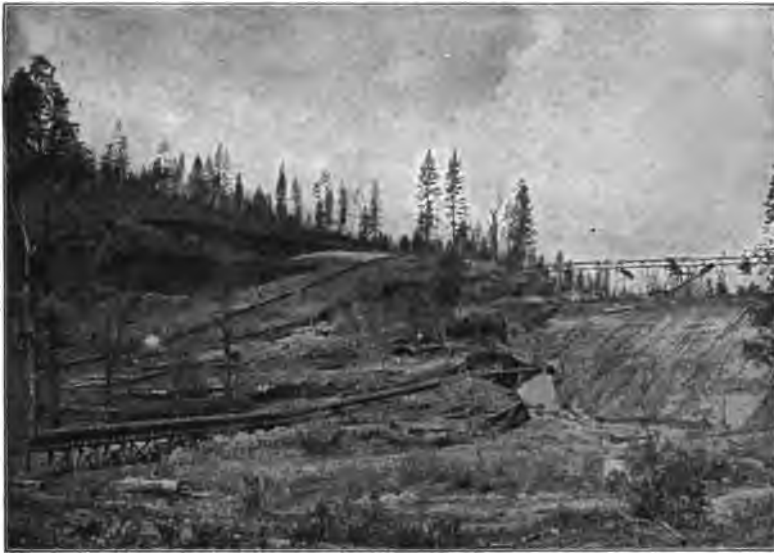
FIG. 88.—WEST END OF LAKE FRANCES DAM, SHOWING THE BREAK RESTORED, THE HIGHER DAM NEARLY COMPLETED, THE HYDRAULIC GIANT AT WORK, AND THE MAIN PIPE LINE SUPPLYING WATER TO THE PUMP.

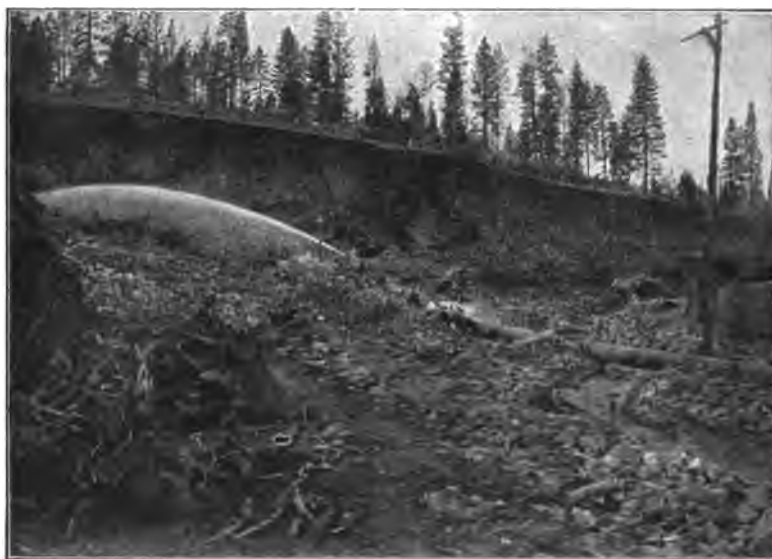
FIG. 89.—HYDRAULIC GIANT IN ACTION UNDERCUTTING THE BANK.

The general plan of building the north face and the top embankment was to deliver the sluiced materials that had been loosened and washed out by the hydraulic giants, under pressure of 40 to 75 pounds per square inch at the nozzle, through a 22-inch riveted steel pipe, placed on a high trestle running parallel with the axis of the dam, and far

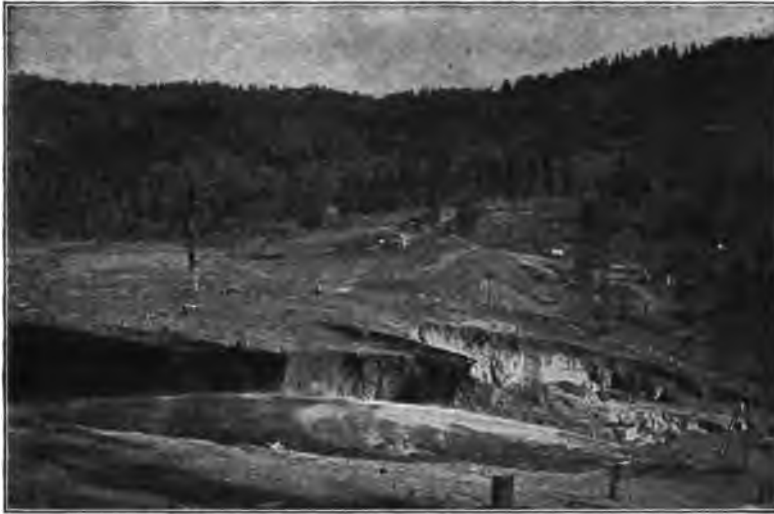
FIG. 90.—LAKE FRANCES DAM, NOVEMBER 6TH, 1901. FROM SOUTH BORROW-PIT, LOOKING ALONG AXIS OF ORIGINAL DAM.

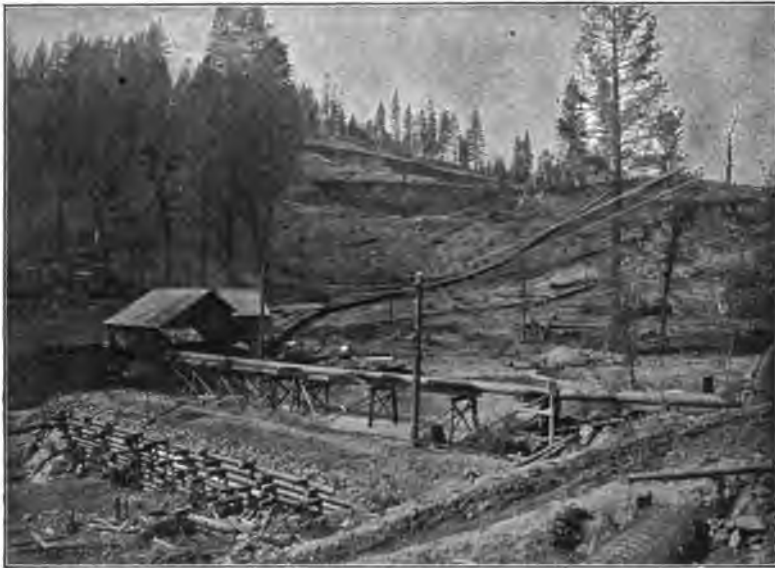
FIG. 91.—LAKE FRANCES DAM CONSTRUCTION. PUMPING STATION, SHOWING SUCTION PIPE CONNECTED TO TANDEM CENTRIFUGAL PUMP. CRIB DAM IN FOREGROUND BUILT TO STORE WATER FOR EARLIER OPERATIONS.

Sluicing with a Pump.—As a gravity water-supply was not obtainable it became necessary not only to pump the water for sluicing, but to build a small storage-reservoir below the dam to store up a supply and pump the water over and over again. Owing to delay in completing the two-stage tandem centrifugal pump (one half of the large pump referred to) on account of a machinists' strike in San Francisco, work was begun on a small scale May 10, 1901, with a 6-inch single-stage centrifugal pump, direct connected to a 30-H.P. motor, installed with

electric current supplied from the Colgate Power House, two miles away. This pump delivered 1.76 second-feet under a head of 100 feet, and did very good service until June 15. By its use 4090 cubic yards were deposited in the repair of the break, at a cost of 18.27 cents per cubic yard. The larger pump was finally installed and put in service Aug. 30, 1901. It continued to supply the water for sluicing until the completion of the dam June 28, 1902.

The pump had a capacity for delivering 6 cubic feet per second, under a pressure of 120 pounds per square inch, through a line of 20-inch

pipe, 300 to 700 feet long. The pump was belt-connected with a 350 H.P. synchronous motor, using alternating electric current at 2400 volts.

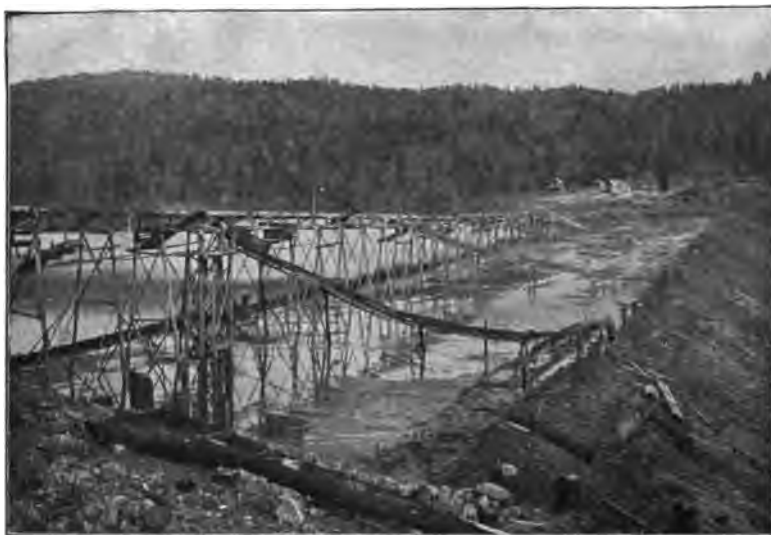
FIG. 92.—LAKE FRANCES, CAL., HYDRAULIC-FILL DAM BUILDING. SHOWING OUTER LEVEES MAINTAINED WITH BRUSH, DEFLECTING BOARDS FOR DISTRIBUTING SLUICINGS ALONG SLOPE, GENTLE SLOPES TOWARD CENTER OF DAM, AND GRADUAL MOVEMENT OF DRAINAGE TOWARD EXTREME END.

the slopes, and prevent slides. It was finally found necessary to resort to the use of pine and cedar boughs and other brush 6 or 8 feet long laid into the slopes with the butts inside, to prevent the tendency to slip. This was effectual in knitting the mass together sufficiently to overcome the sliding and sloughing tendency.

enough inside the slope lines to make delivery through lateral flumes of moderate length, terminating at the edges of the rising embankment. They were of varying length, according to the height at which they were designed to deliver, and were made about 25 feet in average height. The longest trestle with which the additional height of 25 feet above the original dam was built was 1560 feet long, with 13 branch trestles, as shown in Fig. 92. The highest bent in this trestle was 40 feet high.

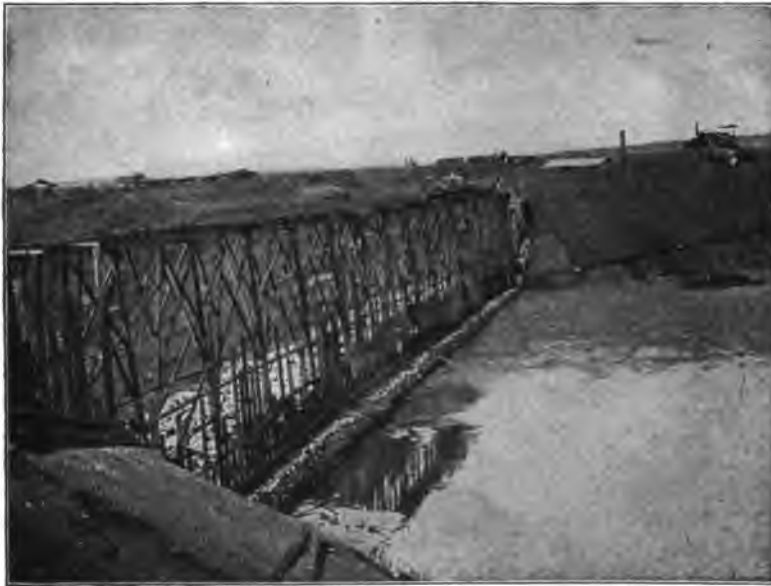
FIG. 95.—WAIALUA DAM, SHOWING HYDRAULIC-FILL BEING SLUICED IN AGAINST THE ROCK-FILL.

They were dumped from the top of a trestle built at the outset to the full height of the dam (see Fig. 95), and the larger stones selected from the dump for laying up the faces of the wall. The height from which the rocks were dropped consolidated the embankment quite effectively, so that little or no settlement has been noticeable since the completion of the dam, although shortly before completion the outer facing wall, some 2 feet thick, bulged out about a foot beyond the slope line over a limited area, indicating that some settlement had occurred. This was corrected

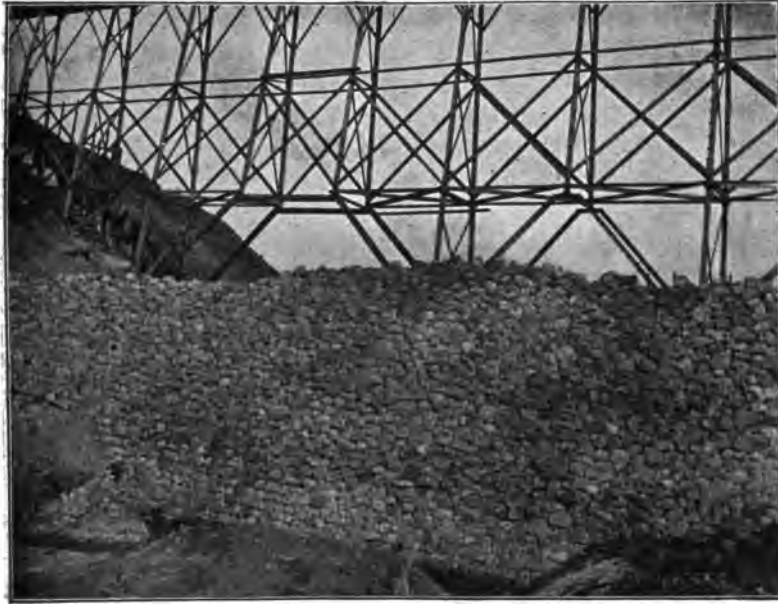
FIG. 96.—ROCK-FILL ON DOWN-STREAM SIDE OF WAIALUA DAM.

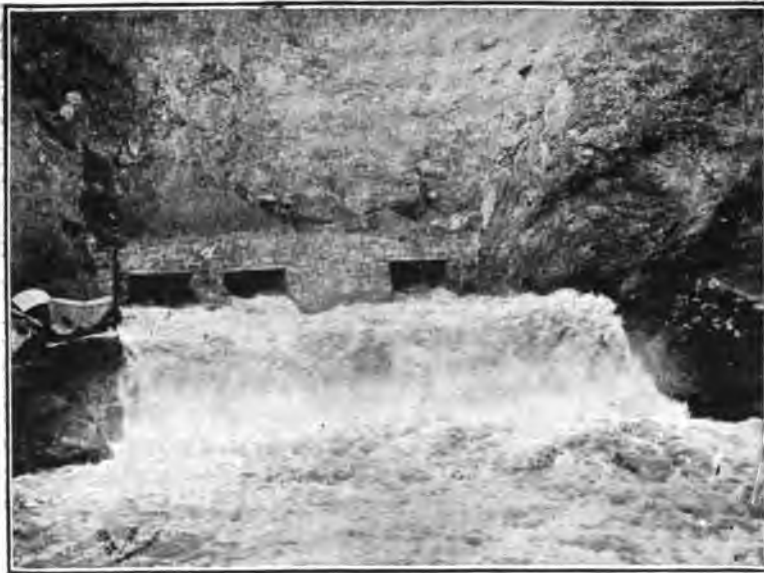
FIG. 97.—WAIALUA DAM, HAWAII, SHOWING FLOOD DISCHARGE THROUGH OUTLET TUNNELS DURING CONSTRUCTION, UNDER HEAD OF 8 FEET AT UPPER END OF TUNNELS.

The trench was cut about 5 feet wide and entirely filled with concrete. The wall extends 2 to 4 feet above the surface, stepped down the sides of the canyon in horizontal and vertical steps as indicated. During construction the flood-waters were handled by a large flume, supplemented by three capacious tunnels, one of which was subsequently

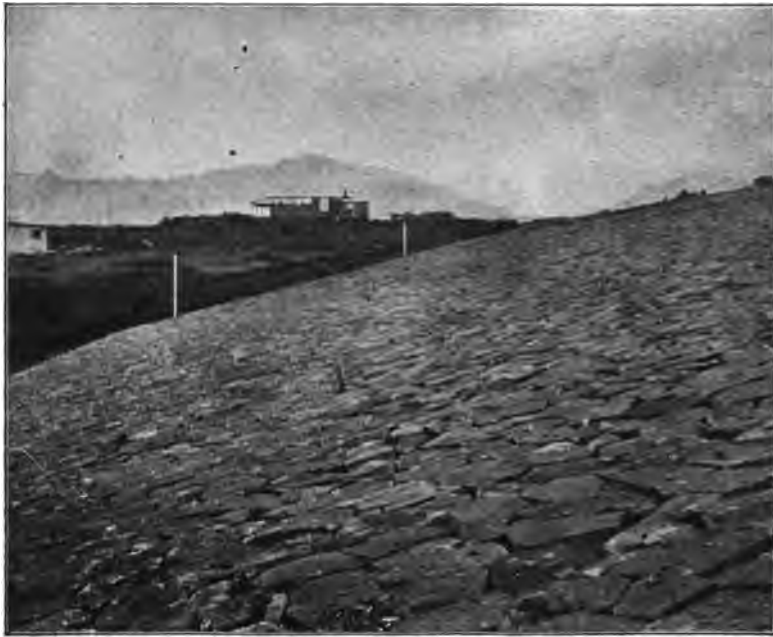
FIG. 98.—RIP-RAP ON FACE OF HYDRAULIC-FILL, WAIALUA DAM.

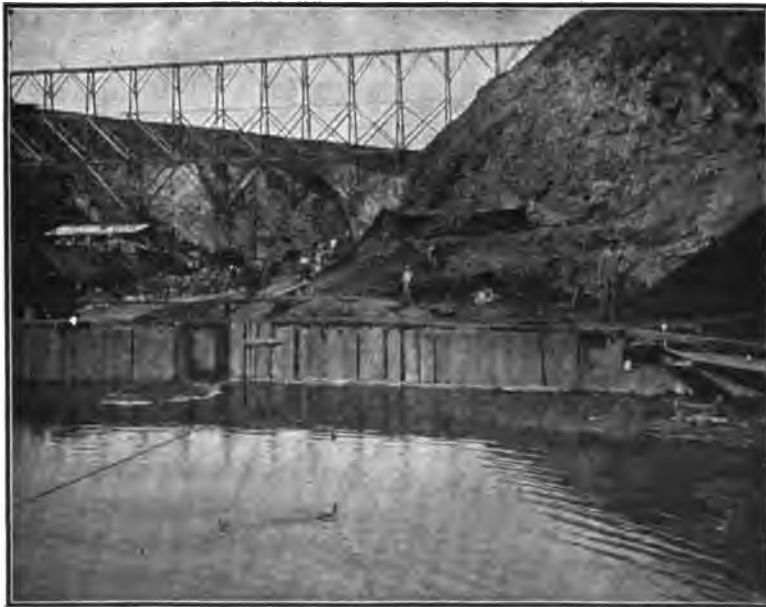
FIG. 99.—WAIALUA DAM, HAWAII. LOOKING DOWN-STREAM THROUGH DAM-SITE, SHOWING DIVERTING DAM AT UPPER TOE, AND TRESTLE FOR MAKING THE ROCK-FILL.

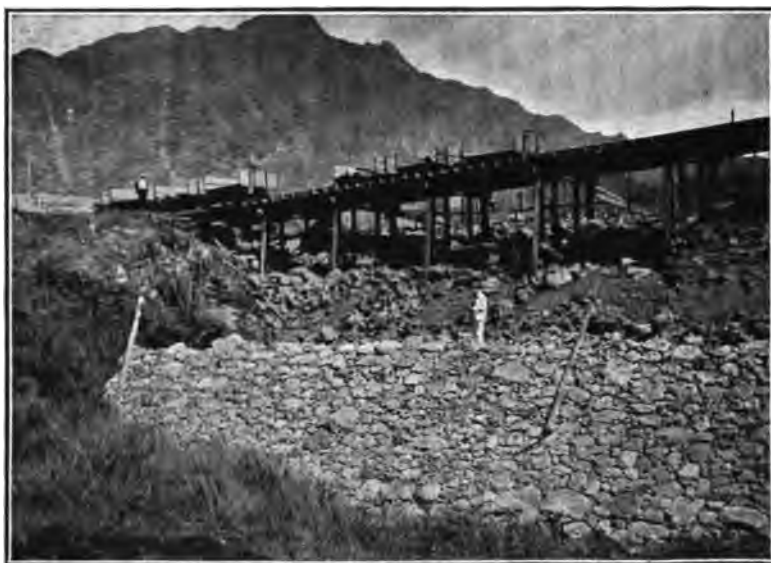
FIG. 100.—NUUANU DAM, HONOLULU, SHOWING TOE OF ROCK-FILL PORTION OF DAM.

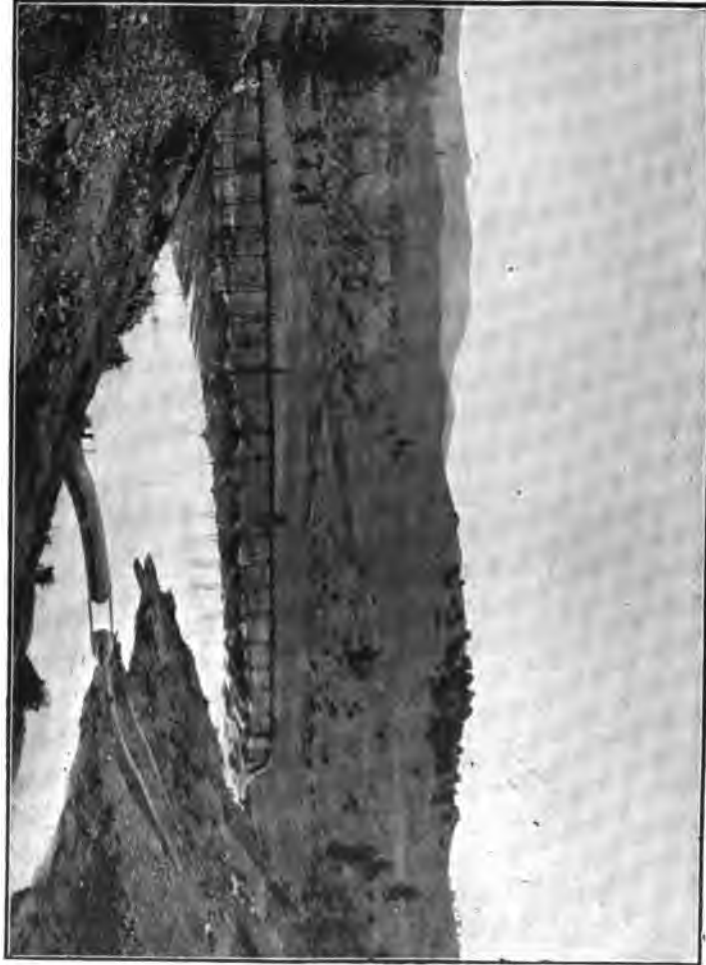
Fig. 102.—TERRACE DAM, COLO., SHOWING DEPOSIT OF STICED MATERIAL ON UP-STREAM TOE OF DAM. THE ABANDONED CORE-WALL, 70 FEET HIGH, SHOWS JUST OUT OF WATER.

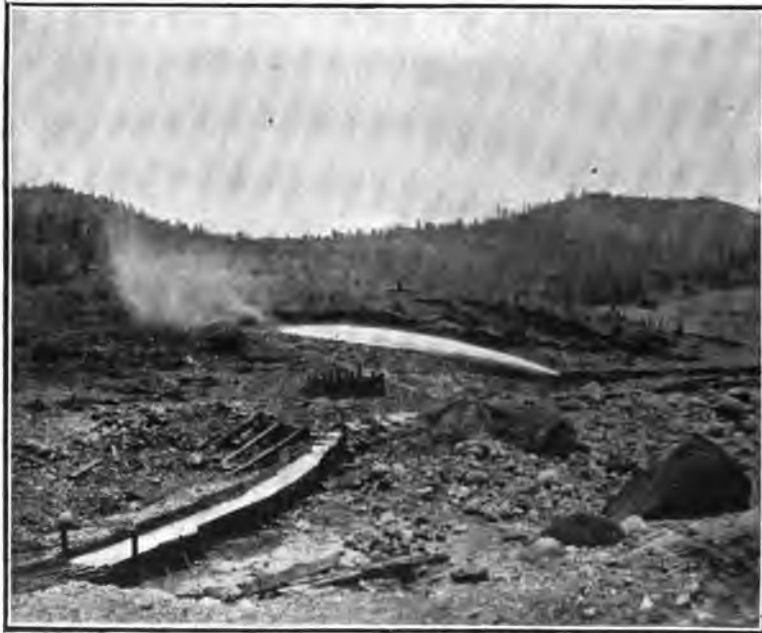
FIG. 103.—HYDRAULIC SLUICING ON THE TERRACE DAM, COLORADO.

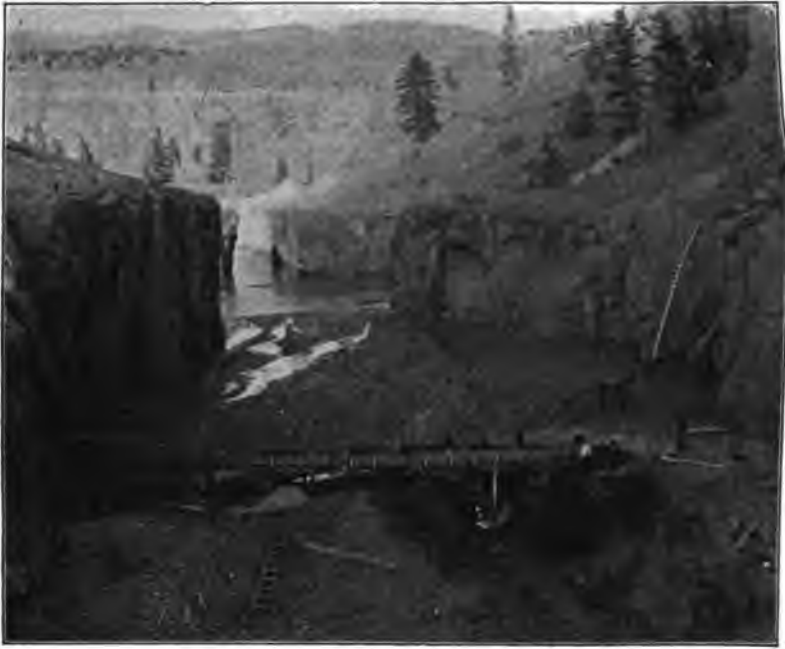
FIG. 104.—TERRACE DAM, COLORADO, LOOKING UP-STREAM. ILLUSTRATING GRADATION OF MATERIAL TOWARD THE CENTER OF THE DAM FROM THE POINT OF DEPOSIT AT THE SLOPES.

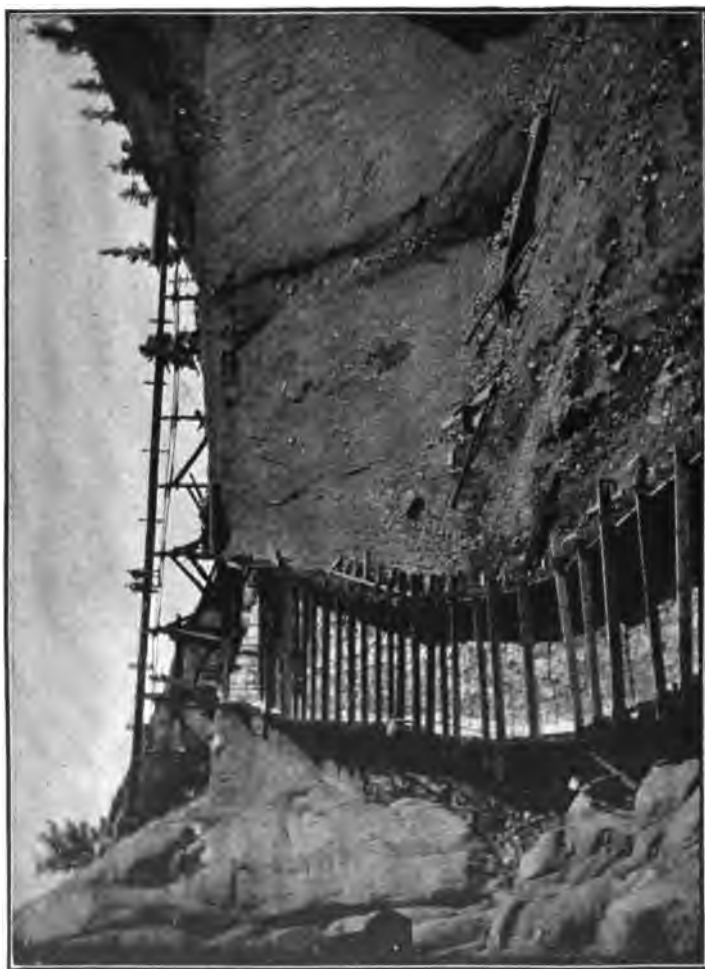
FIG. 106.—WASTEWAY FLUME FOR FLOOD DISCHARGE OVER LOWER SLOPE OF TERRACE DAM.
SUMMER OF 1907.

At the opening of the season of 1907, the company took over the contractor's plant and continued work through the season on its own account. Owing to the small size of the outlet tunnel, it became necessary to build a large flume (Fig. 106) over the top of the unfinished dam

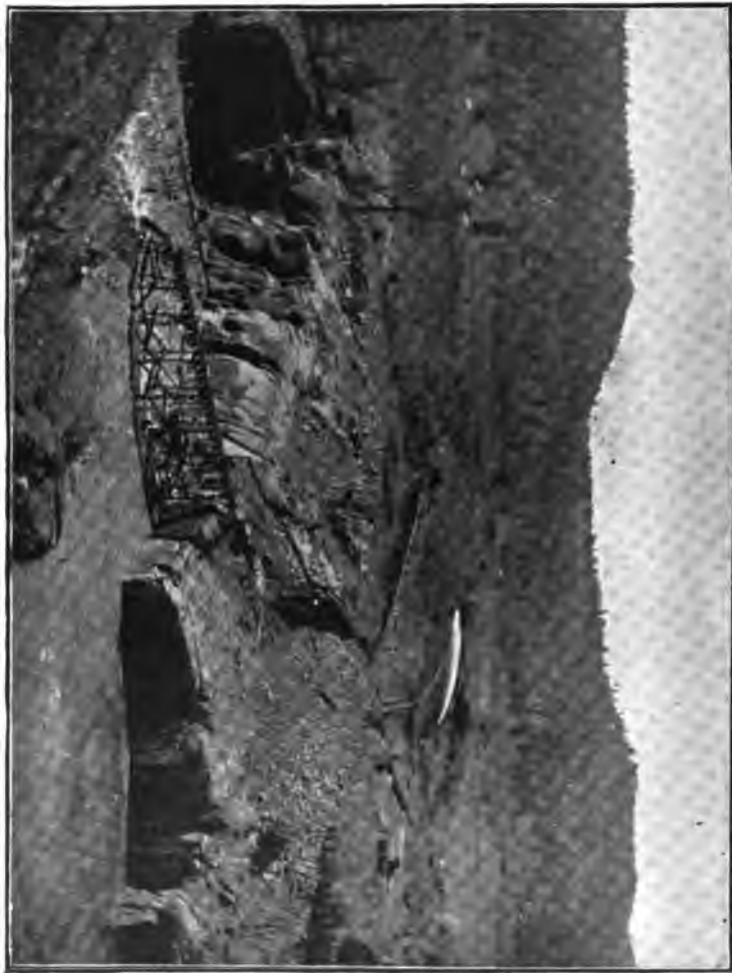
FIG. 107.—VIEW OF LOWER TOE FILLING, TERRACE DAM, COLORADO, SHOWING HYDRAULIC SLICING IN BACKGROUND.
